UNDERGROUND STORAGE TANK (UST) ASSESSMENT REPORT FOR BUILDING 650
CNC CHARLESTON SC
10/04/1996
SOUTH CAROLINA DEPARTMENT OF HEALTH AND ENVIRONMENTAL CONTROL

South Carolina Department of Health and Environmental Control (S.C.D.H.E.C.)
Underground Storage Tank (UST) Assessment Report

Facility Name: Charleston Naval Base Complex, Building 650 /7781

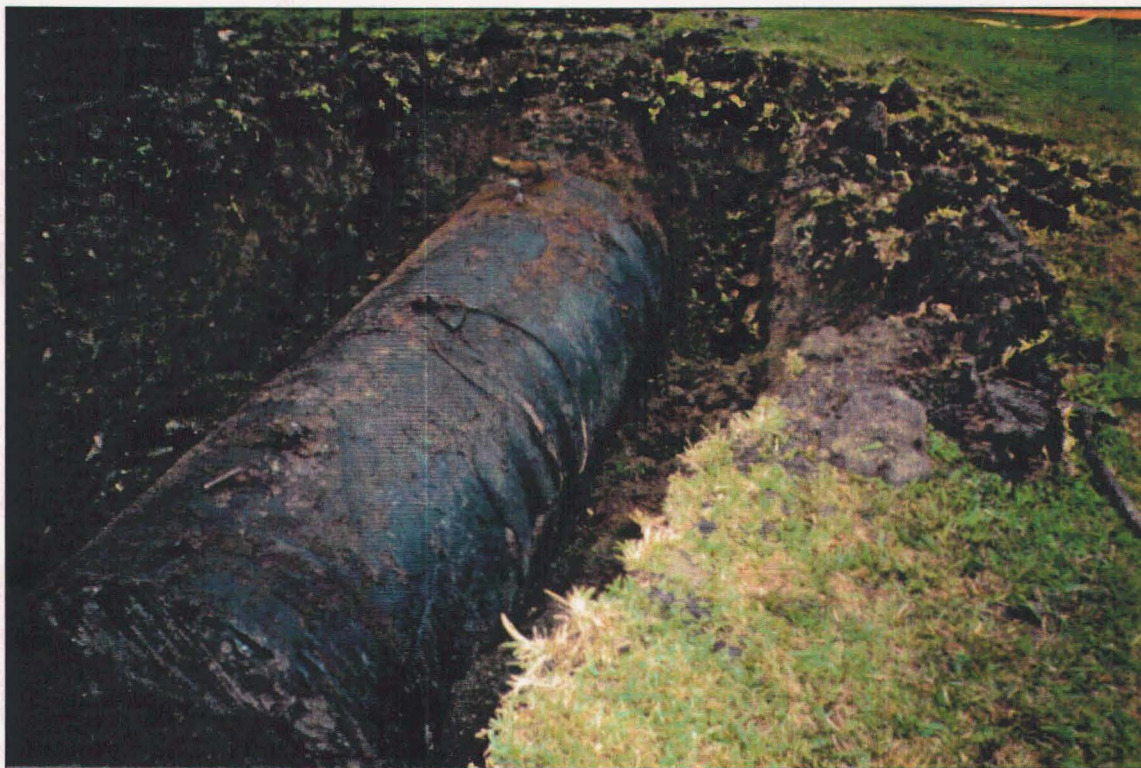
Photo 1: UST 650 partially exposed.

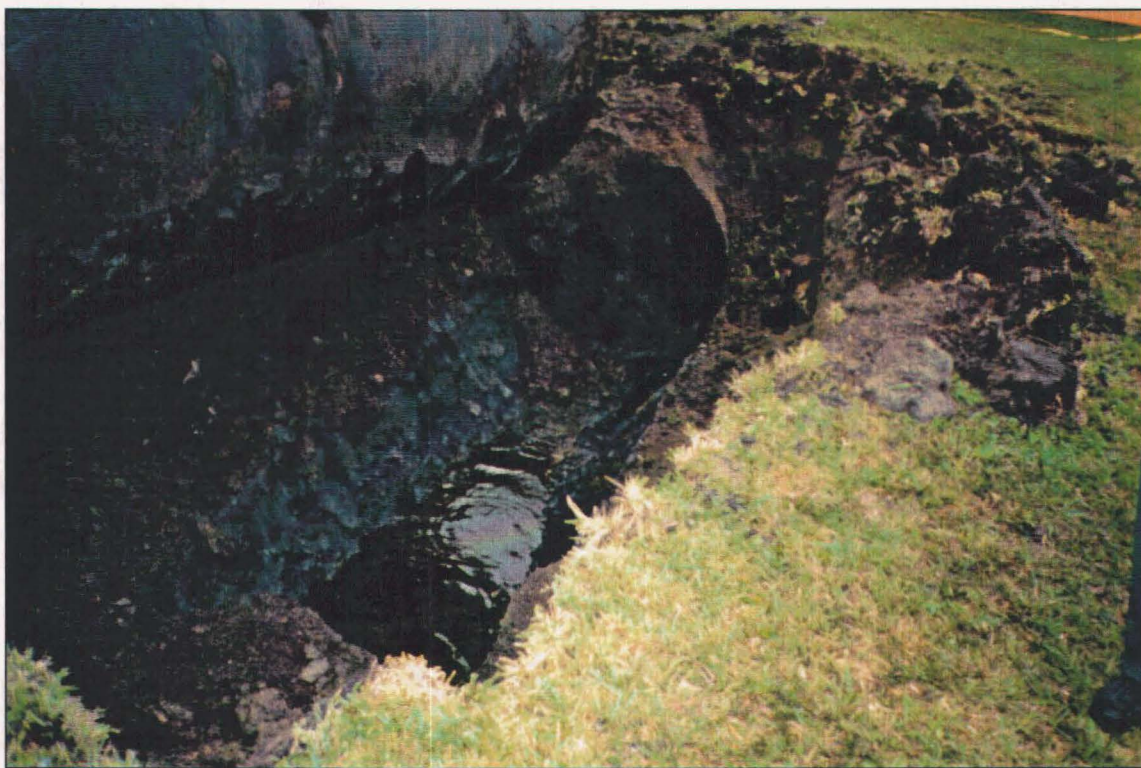
There was a slight sheen on the groundwater in the tank pit. Soil and groundwater samples showed levels of Polynuclear Aromatic Hydrocarbons (PAHs) above the risk based screening levels (RBSLs) established in the "Risk Based Corrective Action (RBCA) for Petroleum Releases". No hole could be found in the tank on site or during cleaning operations, so the petroleum contamination is most probably due to overspill during past fillings.

Photo 2: UST 650 being hoisted from the excavation. Note ground water.

Note 2: Angular rock was used to fill the area covered by the groundwater. Geofabric was laid over the rock and then all soil from the excavation was returned to the tank pit.

Note 3: The groundwater had a light product sheen. This was collected with absorbent rags.

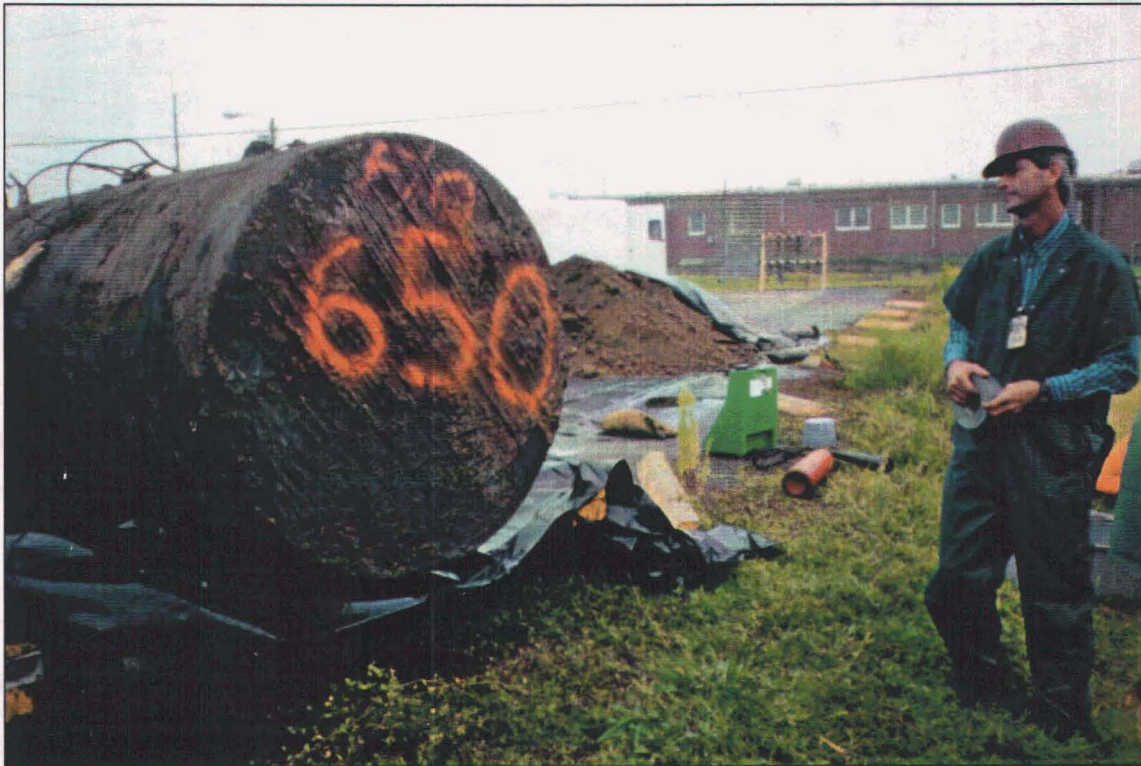
UST 650 had a protective coating on its exterior surface. The tank was in good condition, and suffered no corrosion, holes, or pits.

Photo 3: UST 650 after removal. Note protective coating.

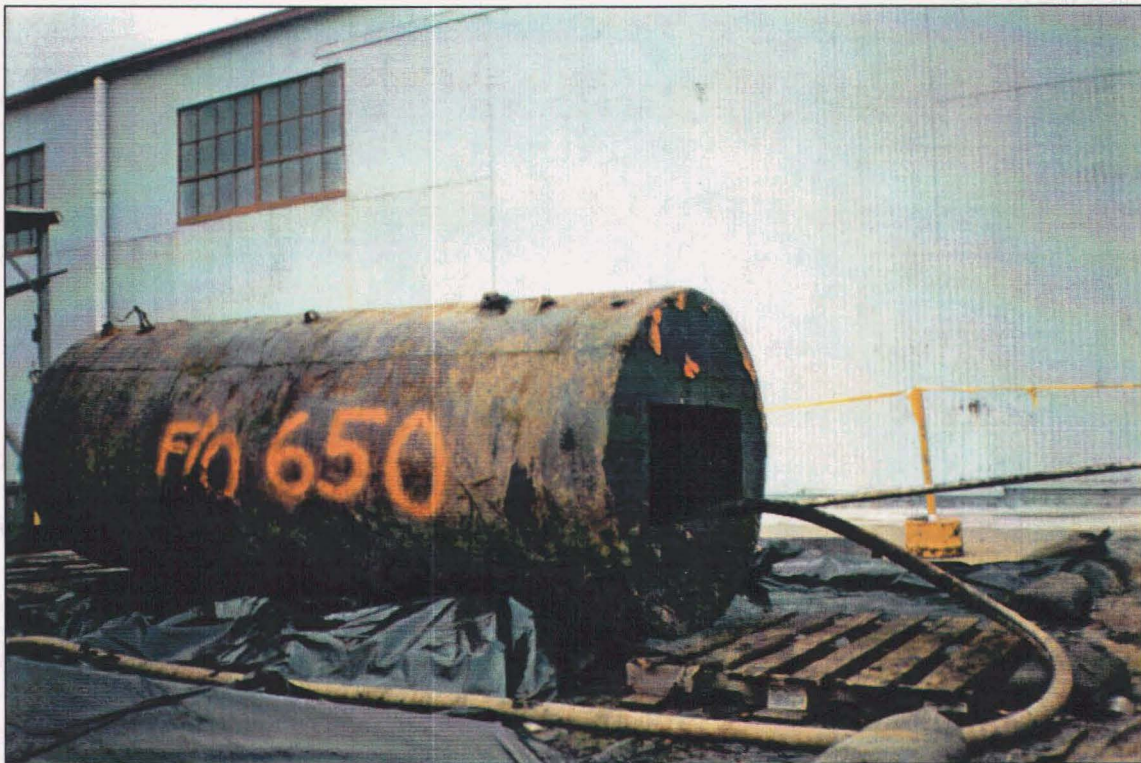
Photo 4: UST 650 being cut and cleaned.

UST 650 was removed, drained, cut open at both ends, and cleaned with a steam cleaner. It was then cut up for recycling as scrap metal. (See Attachment III.)
